Firmware Update (Compatibility w/ IPL Series)

The new PowerLink technology in both IPL-98 & IPL-150 allows for up to four batteries to be stacked charged when used with the VL-2000S charger. To take advantage of this new feature, current owners of the VL-2000S charger will have to install the newest firmware.

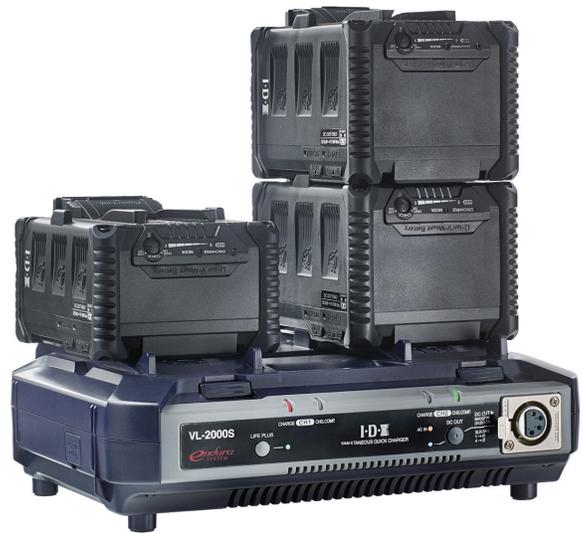
- Windows PC with at least 1x USB port
- USB Flash Drive (blank)

1. Download firmware (.zip) from, <https://bit.ly/2W2vpXM>
2. Unzip and copy the 2 files to the root folder of the blank USB flash drive.
3. Remove all batteries and the AC cable from the charger and wait for all LED to turn off.
4. Insert the USB flash drive with the firmware into the USB port on the side of the charger.
5. Plug in the AC cable.
6. The charger will boot up with all LED lit solid for 3 sec, and then will blink during the installation.
Do not remove the USB flash drive during installation (LED blinking)
7. After a few seconds, LED will turn off and the installation is complete.
8. VL-2000S can now stack charge!
